ELECTRICAL SAFETY FOLLOW UP INSPECTION REPORT (6TH)

Factory Name	UTAH Fashions Ltd			Note:	
Address	South Shalna, Shalna Bazar Gazipur Gazipur Dhaka Bangladesh				
FACTORY ID	9532	ELECTRICAL SAFETY INSPECTION DATES			Other Factory:
Initial Inspection Date		24/04/2014	14/09/2017	Date of 5 th Follow Up	
Report Received Date		04/12/2015	05/09/2018	Date of 6 th Follow Up	
Date of 1st Follow Up		14/10/2015		Date of 7 th Follow Up	
Date of 2nd Follow Up		02/03/2016		Date of 8 th Follow Up	
Date of 3rd Follow Up		02/03/2017		Date of 9 th Follow Up	
Date of 4th Follow Up		30/05/2017		Date of 10 th Follow Up	
Inspected by	Shamim Md Osman

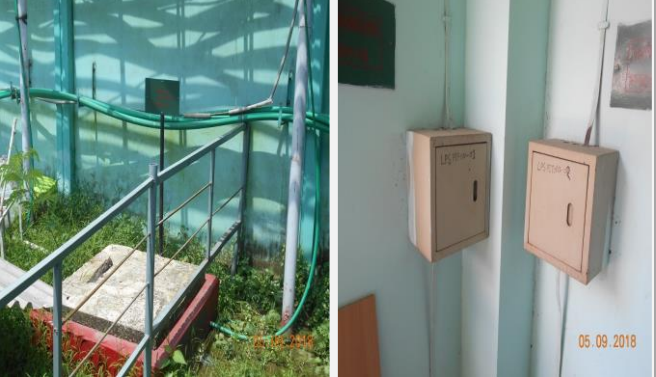
Item No	Accord Inspection Observation	Accord Action Plan (Recommendation)	Accord Time line (given in report)	Comments from Accord (After Physical Inspection)	Final Timeline (Approved timeline)	Final Action Plan (Factory)	Progress Status (On the date of inspection)	Pictorial Evidence
34	New Finding: Earth pits are not identifiable	Each earth pit shall be properly identifiable and marked for periodic maintenance.	1 Month	On 14/09/2017: Not Corrected. Identification is done inside the room & on the busbar only. Provide identification on the earth pit location. On 05/09/2018: Corrected.	'10/07/2017	DONE, We have provided identification marking of all earth pit and performing periodic maintenance.	Corrected

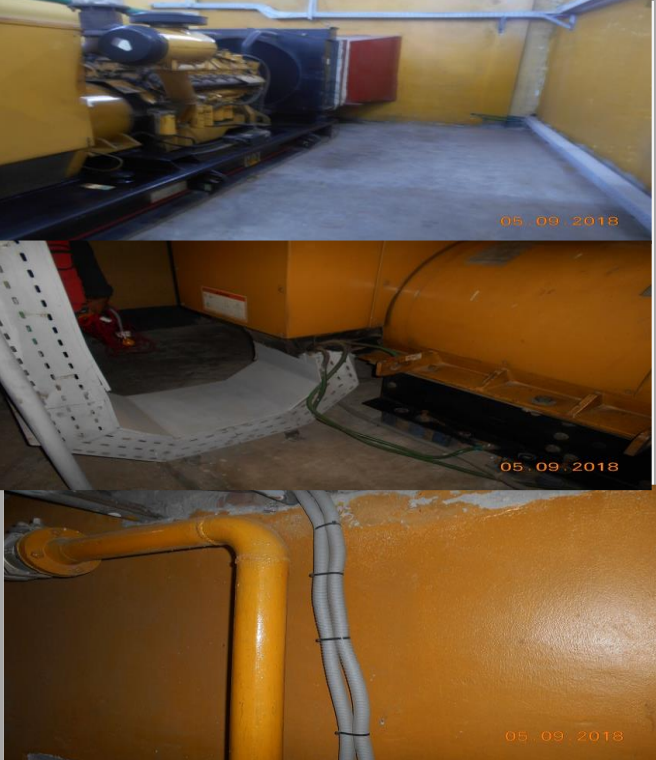
35	<p>New Finding: Floor in generator room is wet.</p> <p>Generator output cables (laid on floor) are not protected and supported</p> <p>Generator output box has openings</p> <p>Generator may be damaged by ingress of rain water & leakage of steam line</p>	<p>Surrounding area of generator room should be clean & dry to avoid any unexpected accident.</p> <p>Service cables from generator must be supported at its own breaker's terminal and with cable tray.</p> <p>Unwanted openings shall be sealed properly.</p> <p>Steps shall be taken to relocate the steam line from generator room & stop ingress of rain water</p>	1 Month	On 14/09/2017: Not Corrected. Generator room is not completely accessible due to massive retrofitting work. On 05/09/2018: Corrected.	'10/07/2017	DONE, We have been completed retrofitting work. Now, Easy access to Generator room for authorized personnel	Corrected

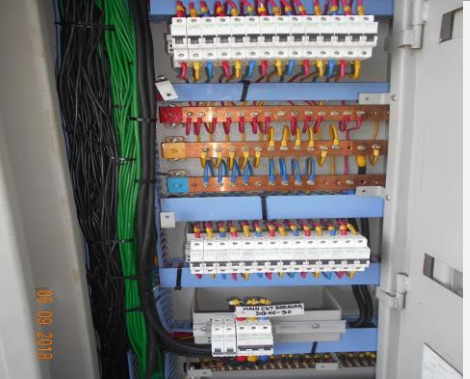
Item No	Accord Inspection Observation	Accord Action Plan (Recommendation)	Accord Time line (given in report)	Comments from Accord (After Physical Inspection)	Final Timeline (Approved timeline)	Final Action Plan (Factory)	Progress Status (On the date of inspection)	Pictorial Evidence
36	New Finding: Power socket is kept on floor	Power socket shall be install at minimum 200mm above the floor with a rigid support.	1 Month	On 05/09/2018: Corrected.	'25/09/2017	DONE / CORRECTED ----- Already we have installed all power socket at minimum 200mm above the floor with a rigid support. Please see the attached evidence	Corrected	 
37	New Finding: Circuit is drawn from bus bar without any protective means	Each electrical circuit must be drawn from distribution board busbar using a proper type protection arrangement (MCCB/MCB).	2 Months	On 05/09/2018: Corrected.	'25/10/2017	DONE, Already we have arranged all electrical circuit drawn from distribution board busbar using a proper type protection (MCCB/MCB).	Corrected

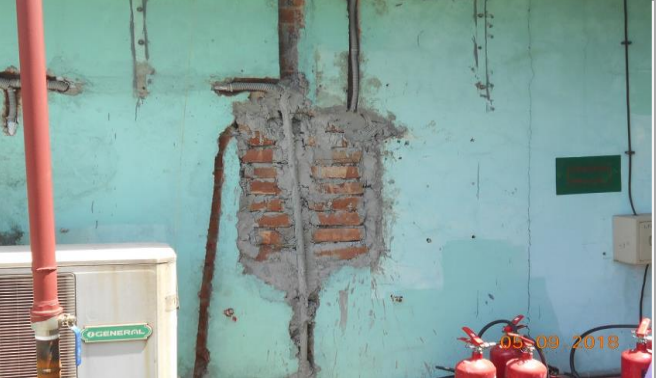
38	New Finding: IP rating of the Panel enclosure installed outdoor is not compatible with the surrounding environment.	Panel board installed exposed to weather, to drip or in abnormally moist atmosphere, the outer casing shall be weather proof and shall be provided with glands or bushings or adapted to receive screwed conduit. IP rating of panel board for outdoor installation shall be according to the surrounding environment.	1 Month	On 05/09/2018: Corrected. The panel has been removed.	'25/09/2017	DONE, Corrective action taken	Corrected
