FIRE SAFETY FOLLOW UP INSPECTION

Factory Name	UTAH Fashions Ltd		Accord ID	9532
Address	South Shalna, Shalna Bazar Gazipur Gazipur Dhaka Bangladesh			
Inspection Date	24/04/2014		Report Received Date	
Date of 1st Follow-up	14/10/2015	Date of 2nd Follow-up	02/03/2016	
Date of 3rd Follow-up	02/03/2017	Date of 4th Follow-up	30/05/2017	
Date of 5th Follow-up	14/09/2017	Date of 6th Follow-up	05/09/2018	
Date of 7th Follow-up		Date of 8th Follow-up		
Date of 9th Follow-up		Date of 10th Follow-up		
Date of 11th Follow-up		Date of 12th Follow-up		
Date of 13th Follow-up		Date of 14th Follow-up		
Inspected by	Md. Mah Mudur Rahman and Md. Tarif Raihan

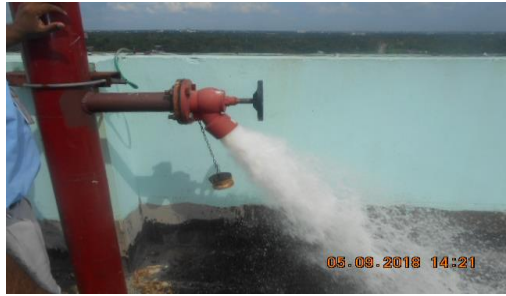
Item No	Accord Observation	Accord Recommendation	Timeline given by Accord	Comments after Physical Inspection	Supposed to complete(DD/MM/YYYY)	Final Action Plan (Factory)	Status on the date of Inspection	Pictorial Evidence
1	Although storage racks and shelves may be compliant, no design specifications were available for review and therefore no indication of class of commodity considered.	Provide design specifications for installed (and new) sprinkler systems and provide evidence compliance of racks and shelves for class of commodity storage.	11/21/2014 12:00:00 AM	On 30/05/2017: Corrected as per previous follow up. On 14/09/2017: Corrected as per previous follow up. On 05/09/2018: Corrected as per previous follow up.	'31/03/2017	Corrected	Corrected	ADD PHOTO
2	Factory has a hose reel system only. In each floor, there is a Type II (38mm) standpipe system. There is no Type I (65mm) standpipe in each stair as per standard.	Install or revise existing standpipe system at required locations designed by a qualified fire protection engineer. System should include rated fire pump and Class III standpipe hose connections (65 mm) in each stairwells at each floor level including occupiable roofs.	11/21/2014 12:00:00 AM	On 14/09/2017: Installation is almost completed. Testing and commissioning of the system will be done by Accord. On 05/09/2018: Corrected. Factory has installed sprinkler system and provided class I connection in the exit stair as per standard.	'31/03/2017	Corrected.	Corrected

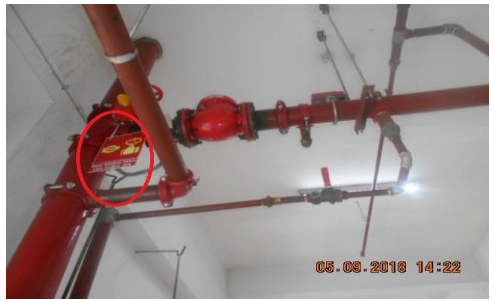
Item No	Accord Observation	Accord Recommendation	Timeline given by Accord	Comments after Physical Inspection	Supposed to complete(DD /MM/YYYY)	Final Action Plan (Factory)	Status on the date of Inspection	Pictorial Evidence
7	A sprinkler system is provided for the storage good area, however, based on Alliance standard, a sprinkler system is required for entire building.	Install an automatic sprinkler system throughout the building designed by a qualified fire protection engineer. The design of the current system should also be reevaluated to assure conformance to NFPA 13	11/21/2014 12:00:00 AM	On 14/09/2017: Installation is almost completed only some few work is pending as building retrofitting work is going on. On 05/09/2018: Corrected. Sprinkler system has been installed as per standard.	'31/03/2017	Corrected.	Corrected

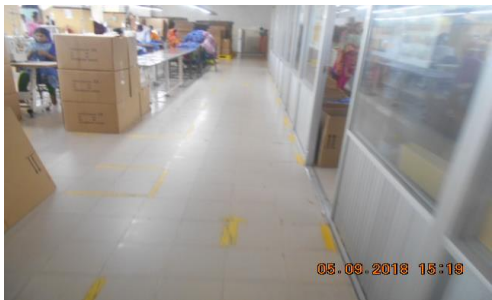
8	Combustible materials were observed stored under cutting tables on Ground Floor	Remove all combustibles stored underneath the cutting tables at the noted locations.	6/30/2014 12:00:00 AM	On 30/05/2017: Corrected as per previous follow up. On 14/09/2017: Corrected. On 05/09/2018: T & C has been done. Factory has installed sprinkler system as per reviewed design and during testing commissioning it was properly functional. The factory needs to maintain in process storage in the production floor based on type of sprinkler which have considered in the design . Alternatively the factory can change the sprinkler heads if required.	'02/03/2016	Corrected	Corrected

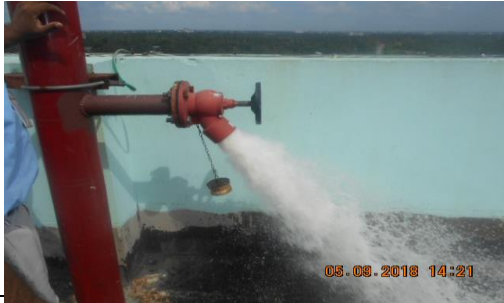
Item No	Accord Observation	Accord Recommendation	Timeline given by Accord	Comments after Physical Inspection	Supposed to complete(DD /MM/YYYY)	Final Action Plan (Factory)	Status on the date of Inspection	Pictorial Evidence
9	As noted elsewhere, factory does not have a compliant standpipe system (hose reel system only) and does not have fire department connections as required.	Upon installation of compliant standpipe system, fire department (Siamese) inlet connections should be installed to allow fire department pumper equipment to supplement the fire protection systems. Signage for standpipe system is not in compliance with NFPA 14 Chapter 6 (e.g. no sign on Fire Department connection indicating STANDPIPE in 1 in lettering)	11/21/2014 12:00:00 AM	On 30/05/2017: It is an integrated part of fire fighting system. On 14/09/2017: Corrected. Provided. On 05/09/2018: Corrected as per previous follow up.	'31/03/2017	Corrected	Corrected

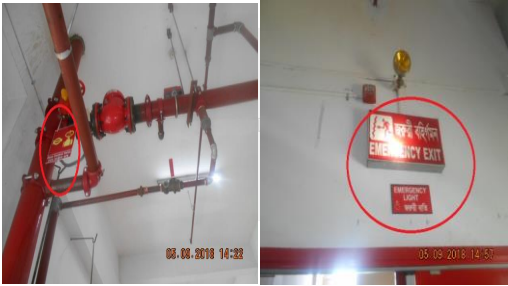
28	Identification signs for the sprinkler system were not installed as per NFPA 13.	Install identification signage at the required locations for all existing (and newly installed) sprinkler systems. The five basic types of identification signs are as follows: Type A- Control Valve Sign Type B- Multi-Purpose Text Signs (See Below) Type D- Fire Alarm Sign Type E- Hydraulic Calculation Sign Reference NFPA 13 for signage requirements	11/21/2014 12:00:00 AM	On 14/09/2017: Installation is almost completed only some few work is pending as building retrofitting work is going on. On 05/09/2018: Corrected. Signs has been installed.	'31/03/2017	Corrected.	Corrected

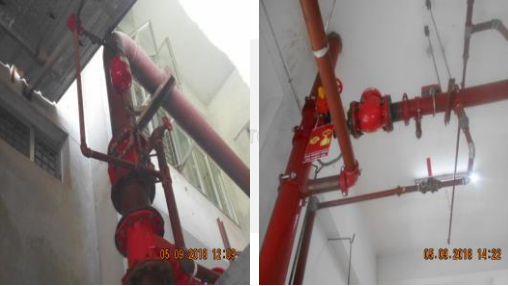
29	Automatic sprinkler systems installed in storage areas do not have an approved audible device activated by waterflow equal to the flow of one sprinkler.	Install an approved audible device connected to every automatic sprinkler system (existing and newly installed) and activated by waterflow equal to the flow of one sprinkler. Activation of the waterflow shall activate the fire alarm system.	11/21/2014 12:00:00 AM	On 14/09/2017: Installation is almost completed only some few work is pending as building retrofitting work is going on. On 05/09/2018: T&C has been conducted by ACCORD. Sprinkler system has been installed as per standard.	'31/03/2017	Corrected.	Corrected

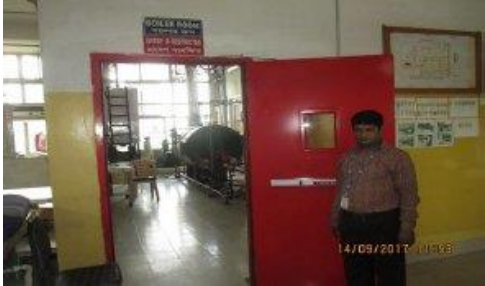
Item No	Accord Observation	Accord Recommendation	Timeline given by Accord	Comments after Physical Inspection	Supposed to complete(DD /MM/YYYY)	Final Action Plan (Factory)	Status on the date of Inspection	Pictorial Evidence
33	New Finding: Unsealed penetrations and openings are located in Boiler room which discharges in the production floor.	Seal all penetrations and openings which discharges in the production floor in the wall of boiler (full thickness of the wall) by fire rated materials to maintain the fire resistance rating.		On 02/03/2016: Corrected On 30/05/2017: Corrected as per previous follow up. On 14/09/2017: Corrected. On 05/09/2018: Corrected as per previous follow up.	'02/03/2016	Corrected	Corrected

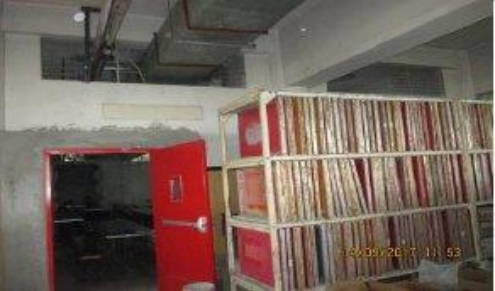
35	New Finding(2nd Follow-Up): The dining area and prayer room in the third floor is not separated from adjacent production floor area by fire rated construction.	Separate the dining area and prayer room by a minimum 3-hr fire-rated construction having a direct access to exit stair. Seal and/or protected all openings to maintain the required fire separations.		On 02/03/2016: In progress. On 30/05/2017: No action has been taken yet. On 14/09/2017: Fire door installed but ventilation opening not sealed yet. On 05/09/2018: Corrected . Fire door installed and opening has been sealed.	'30/11/2016	Corrected. We have already separated the dining and prayer room.	Corrected
